**TORRO SITE INVESTIGATION**  
**SUMMARY REPORT**  
**Chobham, Surrey**  
**8 June 2026**

Report number: SI20260608\_Chobham

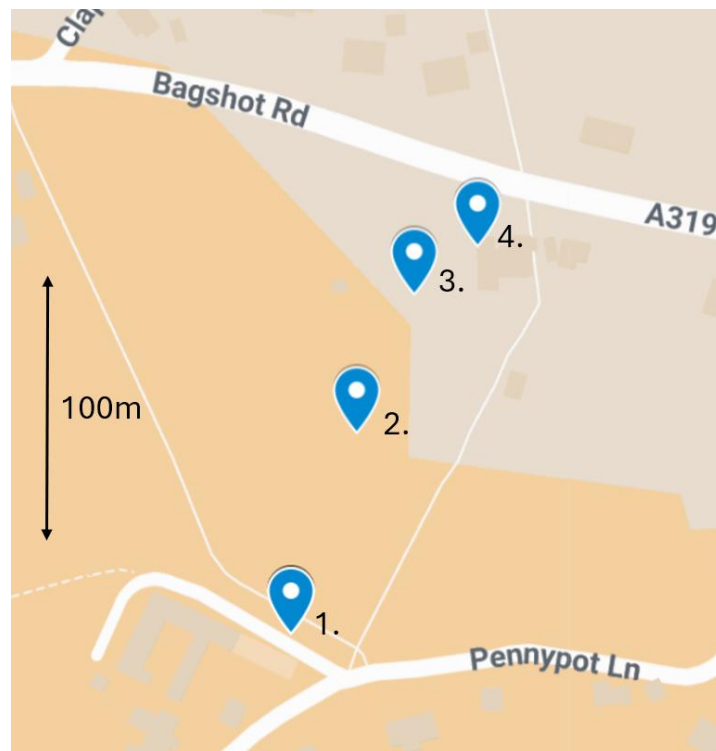
**Figure 1:** Damage track of the Chobham tornado (2026). Marker numbers correspond to damage descriptions in the section below. Map data ©2026 Google.

1. The first evidence of damage was located at the tree line to the SW (51.3459, -0.6166), where a very rotten tree of 40cm diameter had snapped at its base. There is some uncertainty as to how recent this damage was and therefore this may not be a reliable indicator. A small amount of branch damage was also noted nearby. **Intensity rating: T1**

2. At a livery adjoining the nursery (51.3465, -0.6163), stables were found moved off their base. The owner had been away and returned to find their belongings disturbed, remarking that it looked as though a tornado had come through. **Intensity rating: T1**

3. At the plant nursery (51.3469, -0.6160), witnesses reported light rain and calm winds before noticing a disturbance in the trees to the SW and a narrow tornado approaching. Occupants ran for the gazebos in an attempt to hold them down but were unsuccessful; one woman was thrown perpendicular to the track and ended up tangled with a mangled gazebo frame and plants, though she showed no visible injury afterwards. Plants were left lying in a distinctive circular pattern. A well-constructed shed nearby remained intact, but the nursery's shipping container (unsecured) was found moved off its fixed points. The tornado appeared to dissipate on leaving the nursery. **Intensity rating: T1**

4. Approximately 20m further along the track, guttering was removed from a house (51.3471, -0.6157). **Intensity rating: T1**
