**TORRO SITE INVESTIGATION**  
**SUMMARY REPORT**  
**Coldwood, County Galway, Eire**  
**26 June 2026**

Report number: SI20260626\_Coldwood

### Site Investigation summary

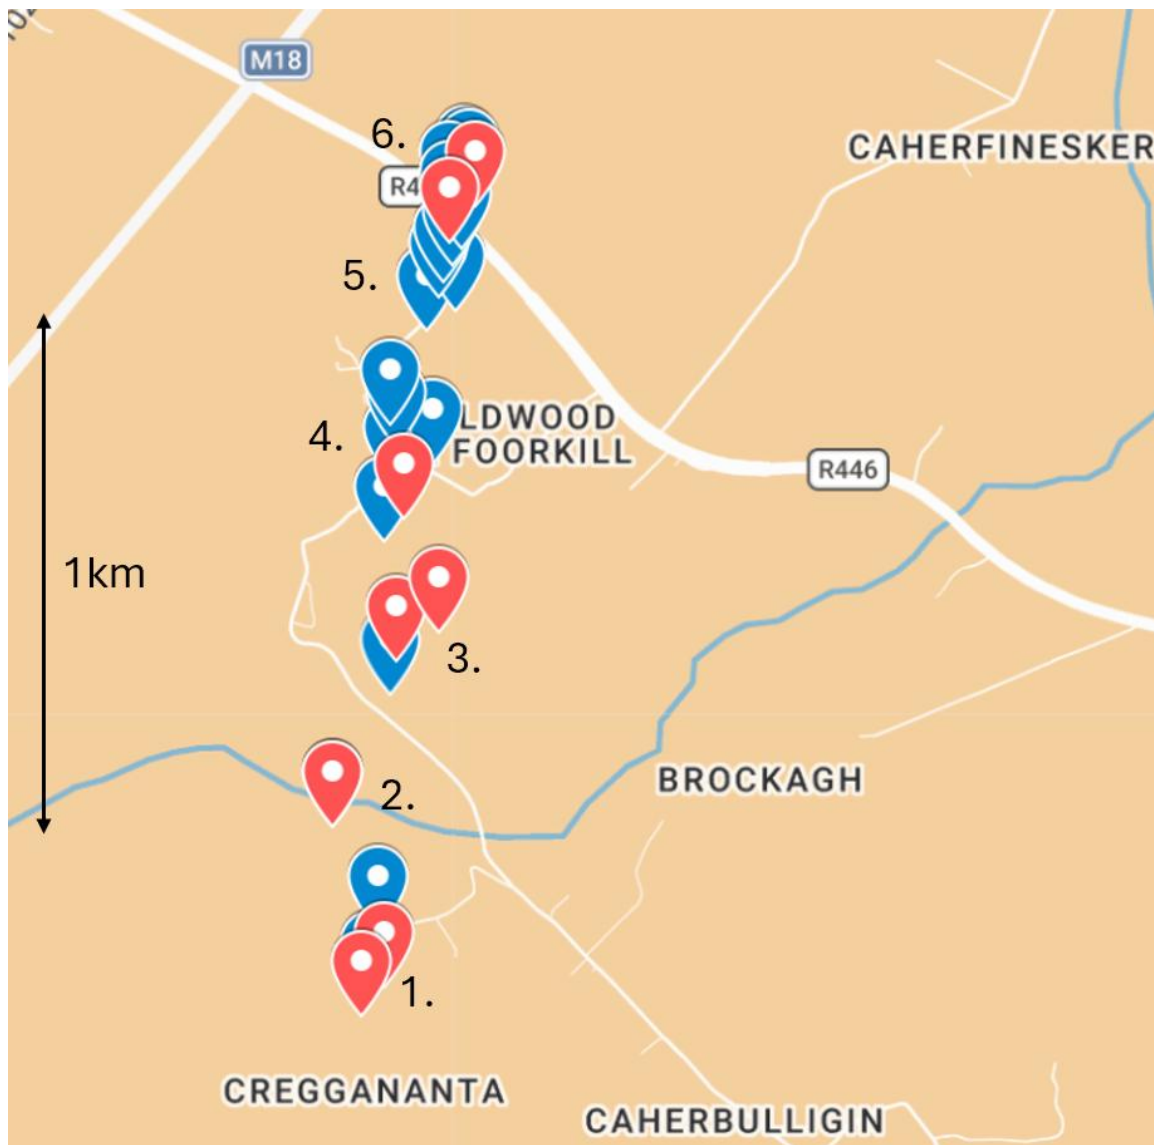
**Figure 1:** Damage track of the Coldwood tornado (2026). Blue markers are damage points recorded in person by John Murphy, Red markers are damage points located by drone imagery. Map data ©2026 Google.

1. The first evidence of damage was located here. At least two trees were felled though the failure point of one (53.2466, -8.8138) was unclear - the second (53.2470, -8.8135), was uprooted and fell approx. W, dislodging a stone wall covered in vegetation. Fascia boards were reported damaged and leisure equipment (a football goal and a trampoline) was relocated and/or damaged by the tornado. **Intensity rating: T2**

2. An ash tree was snapped at its base and fell E. (53.2501, -8.8146) **Intensity rating: T2**
3. Windows which had been left on the latch were 'sucked out' and required repair (53.2524, -8.8130). A small tree had snapped near the base. **Intensity rating: T1**

4. Multiple trees, including an ash tree and a chestnut tree suffered damage, with snapped branches. In addition, drone footage revealed what appeared to be fallen trees. One house (53.2569, -8.8128) lost a number of slates. **Intensity rating: T2**

5. In this location damage density intensified. At 53.2596, -8.8115 a large ash tree had fallen onto a power cable. At 53.2602, -8.8111 multiple trees had fallen across the road. At 53.2605, -8.8109 a power pole was found to be snapped at the base. It is assumed that this was due to the weight of trees falling on the cable. Drone footage of this area showed grass flattened by strong winds, though the boundaries of the affected area were difficult to determine. **Intensity rating: T2**

6. Around 53.2615, -8.8106 a property owner reported that multiple trees were felled. A 'garden bunker shed' was destroyed and a steel garden table thrown 20m.

It is possible that in this location we have underrated the tornado intensity. **Estimated intensity rating: T2**
