**TORRO SITE INVESTIGATION**  
**SUMMARY REPORT**  
**Chobham, Surrey**  
**8 June 2026**

Report number: SI20260608\_Chobham

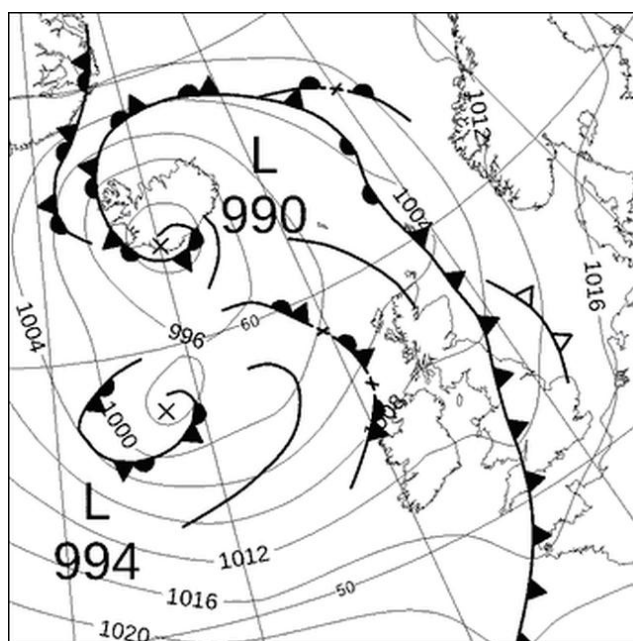
**Figure 2:** Met Office analysis valid 06 UTC 8 June 2026. Original chart: Crown copyright (2026).

This event occurred on a narrow cold-frontal rain band embedded within a wide cold-frontal rain band, trailing from a complex area of low pressure with a centre over Iceland.

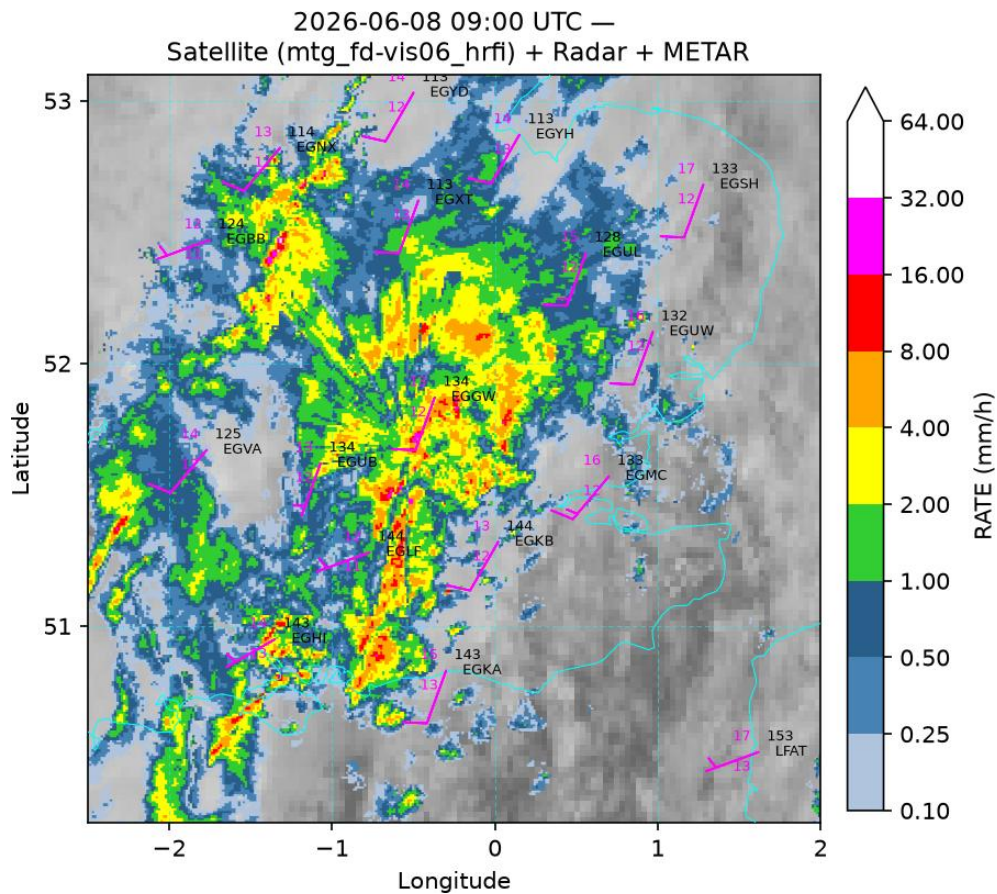
**Figure 3:** Network radar imagery, visible satellite image and surface observation 09 UTC.

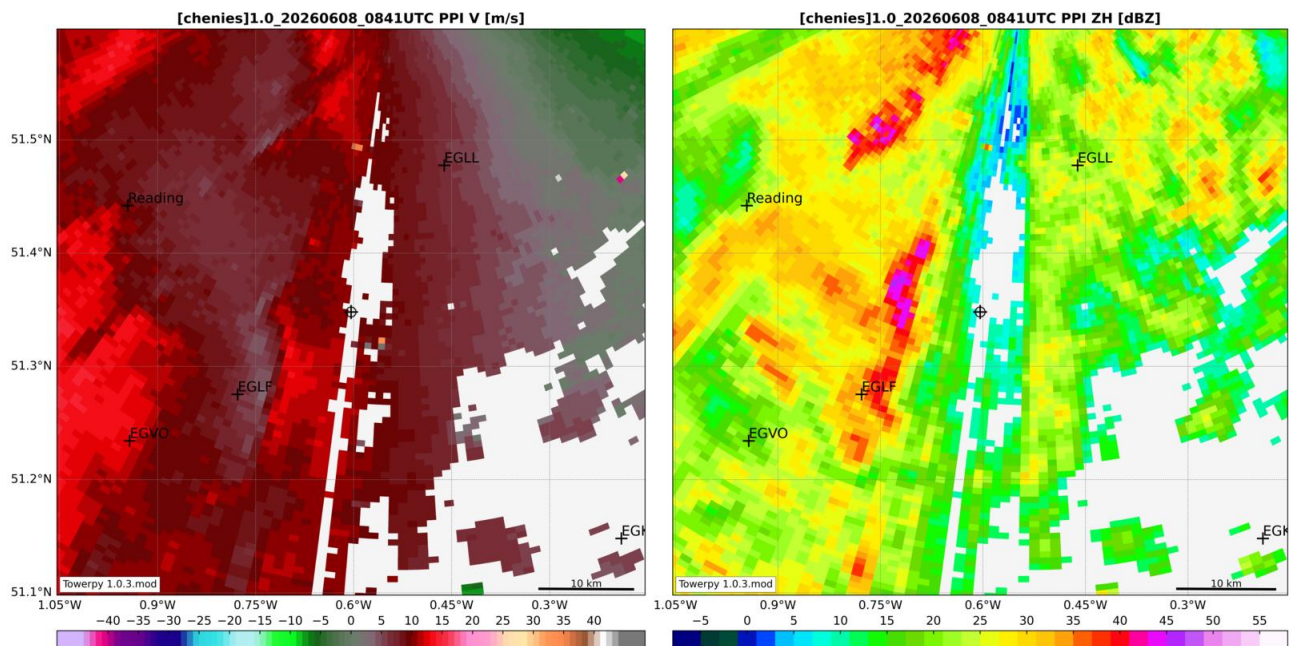
**Figure 4:** Single-site radar images from the Chenies radar 0841 UTC. Chobham is located at the target marker.

Relevant single-site imagery from the Chenies radar is compromised by 'spoking' artefacts. The 0841 UTC scan (Fig 4) and 0901 scans (not shown) suggests the event occurred as a short line-segment on the cold front crossed the area (the 0851 image is marred by attenuation). The 0841 radial velocity image indicates there was detectable wind shear along this segment. Thus the tornado may have been associated with core-gap morphology and was likely 'miso-cyclonic' in nature.
